A Low Distortion AM Detector and AGC System

By Steve Cloutier, WA1QIX

Revision 2.2, Feb, 2007

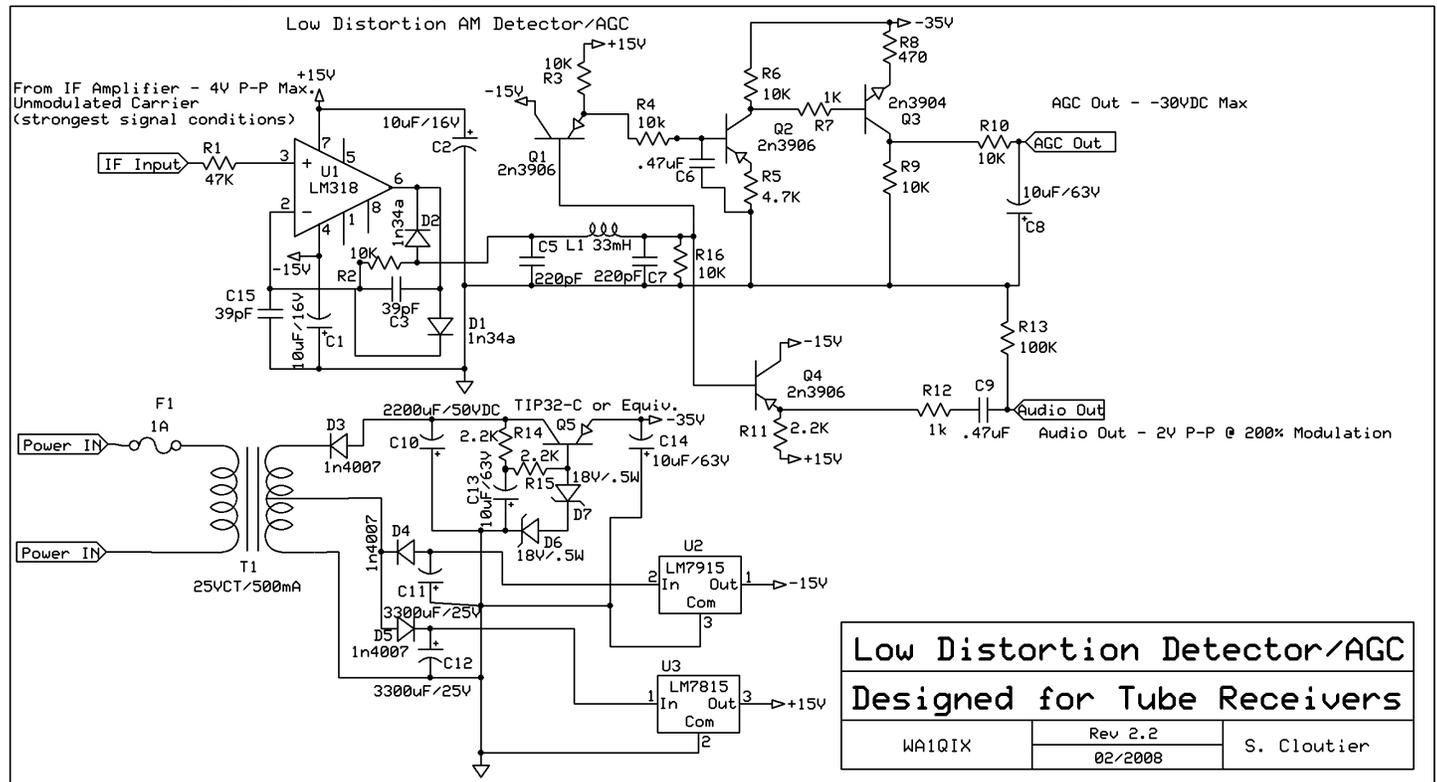
The schematic shows a complete circuit diagram of the Low Distortion AM Detector and AGC system.

The LM318 op-amp (U1) forms a precision rectifier, which creates a very low distortion detector. The negative-going output of the detector is filtered by C5-L1-C7. The filter output is buffered by transistor Q4, which forms an emitter follower. The output of Q4 is then fed to the audio system.

A second buffer amplifier, Q1, drives the AGC amplifier formed by Q2 and Q3. The AGC signal is filtered in two places: by R4-C6 and by R10-C8. The filter effectively removes any audio frequencies greater than a couple of cycles per second from the AGC output. The AGC output is connected directly to the AGC line of the receiver, and up to -30 volts can be developed. This is generally more than sufficient to cut off most vacuum tubes, and should be sufficient for virtually all applications.

The power supply delivers three voltages using a single center-tapped transformer and three voltage regulators.

The 455kHz IF signal from the last IF amplifier of the existing receiver is fed to the IF input of the detector circuit. The input is a very high impedance (in the order of many mega ohms), and does not significantly load the last IF stage of the receiver.

The circuit should be built on a piece of copper clad board. So-called “dead bug” construction works very well for this application, as the circuit does use RF energy, and therefore good bypassing and a good ground plane are very important for stable operation. Perf board or other non-ground plane construction techniques are not recommended.

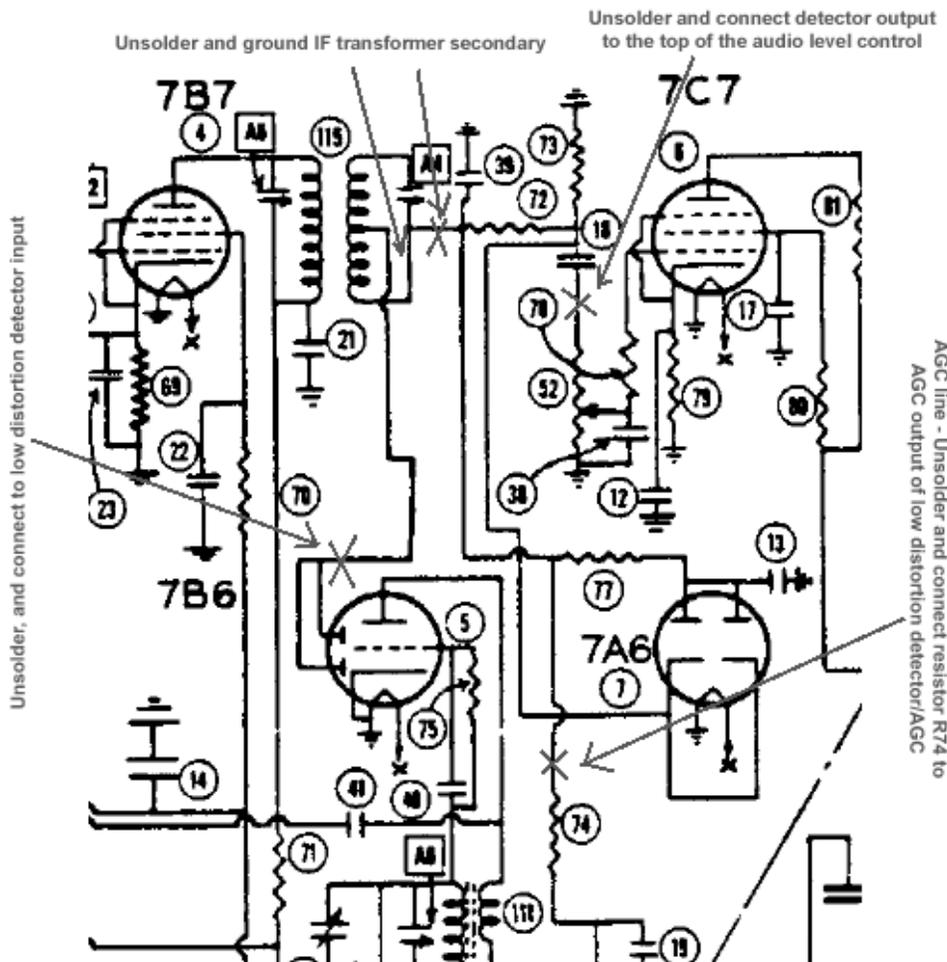
The schematic section shows the last IF and detector/AGC of an RME-45 receiver, and the connection points for the low distortion detector. This is one example. Other receivers will most certainly vary in their detector/AGC implementations, however by locating the appropriate connection points, connection of the low distortion detector should be possible with virtually all vacuum tube receivers.

It is very important that the receiver’s IF output be DC ground referenced. One side of the IF transformer secondary should be at RF ground, and preferably at DC ground as well. The other side of the IF amplifier secondary should feed the detector circuit. If it is not possible to achieve a DC ground referenced IF output, a suitable RF choke should be installed between the IF output and ground to establish a DC ground reference.

No other circuitry should be connected to the last IF amplifier output, and in most cases the secondary can be disconnected from the existing receiver circuitry, and connected to the low distortion detector circuit. Since one side of the last IF transformer is connected to the detector in the receiver, this can be disconnected and connected to the low distortion detector. The other side of the IF transformer secondary can usually be grounded, at least at RF.

Generally, there is a single feed point for the receiver's AGC. This point should be located by consulting a schematic diagram of the receiver, and should be disconnected from the original AGC circuitry within the receiver. The AGC line is then connected to the AGC output of the low distortion detector.
